Evaluation of a Retrofit OH-58 Pilot's Seat to Prevent Back Injury

Joseph L. Haley, Jr.
COBRO Corporation

December 1994

United States Army Aeromedical Research Laboratory
Fort Rucker, Alabama 36362-0577

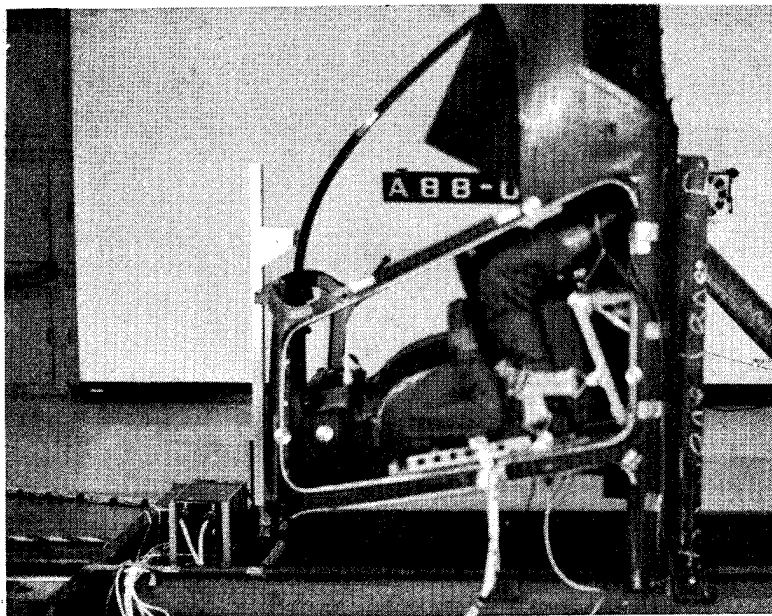
Figure 14. Posttest view of test 88057. (Note the stroked position of the bottom armor plate.)

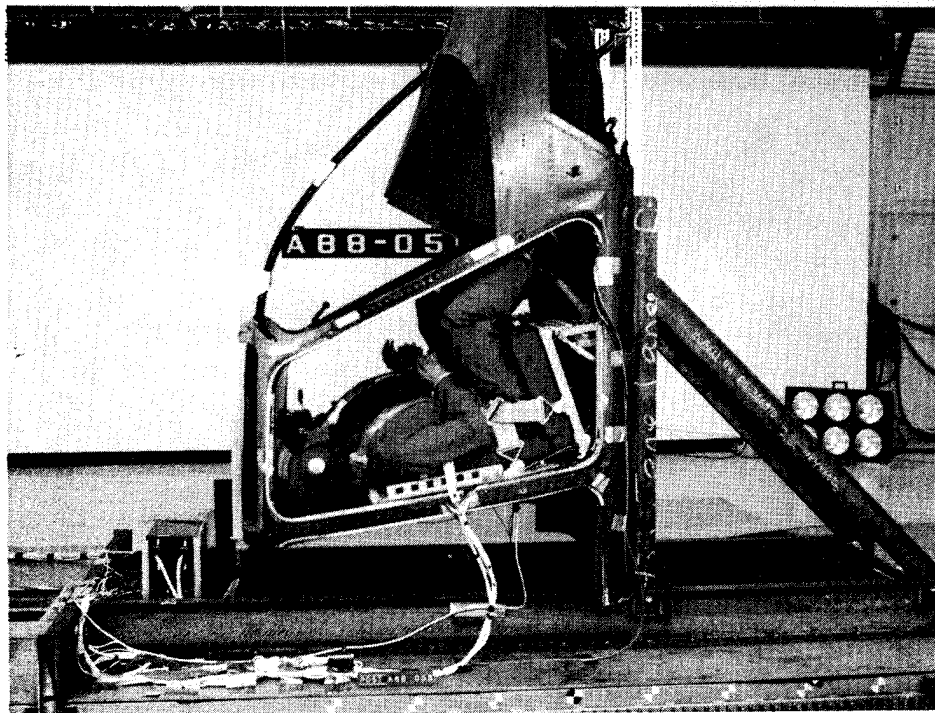
Figure 19. Posttest view of test 88058 (note the stroked position of the bottom armor plate).

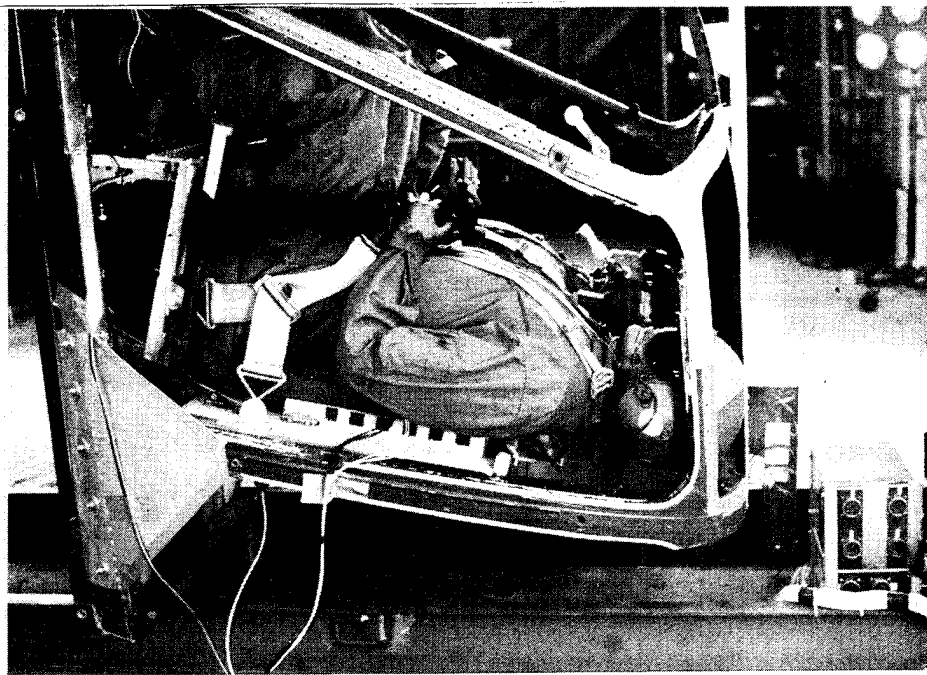
Figure 20. Posttest view of test 88058, showing 95th percentile VIP dummy (note the .05-inch thick aluminum sheet used to stabilize the floor-to-bulkhead joint, and the slack in the wire bender at point "W").

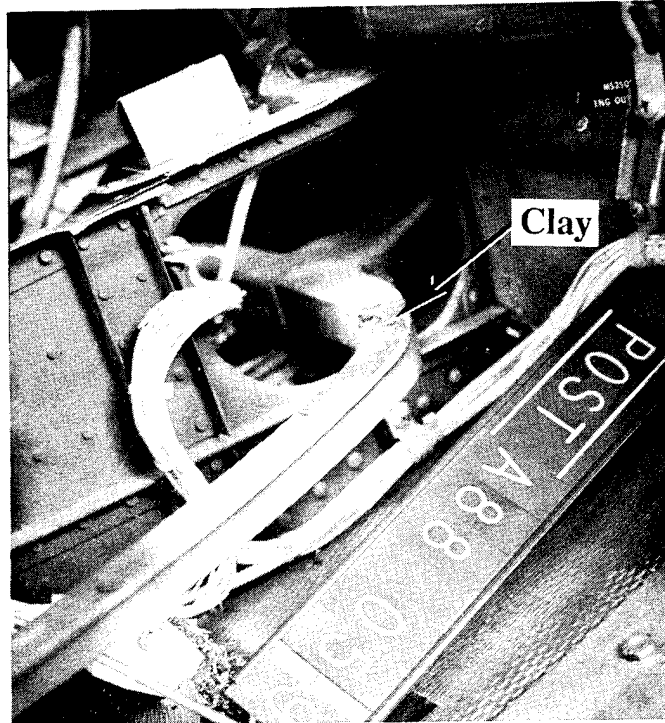
Figure 23. Modeler's clay on underfloor yoke revealing the impact point of the left armor plate (note failure of BL 5.21 brace tube anchorage).

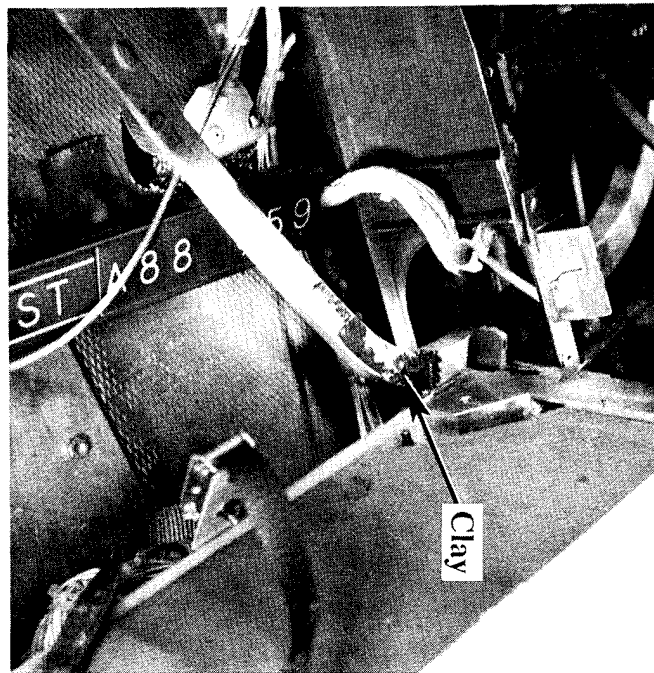
Figure 24. Underfloor yoke impact at bottom armor plate rear edge.

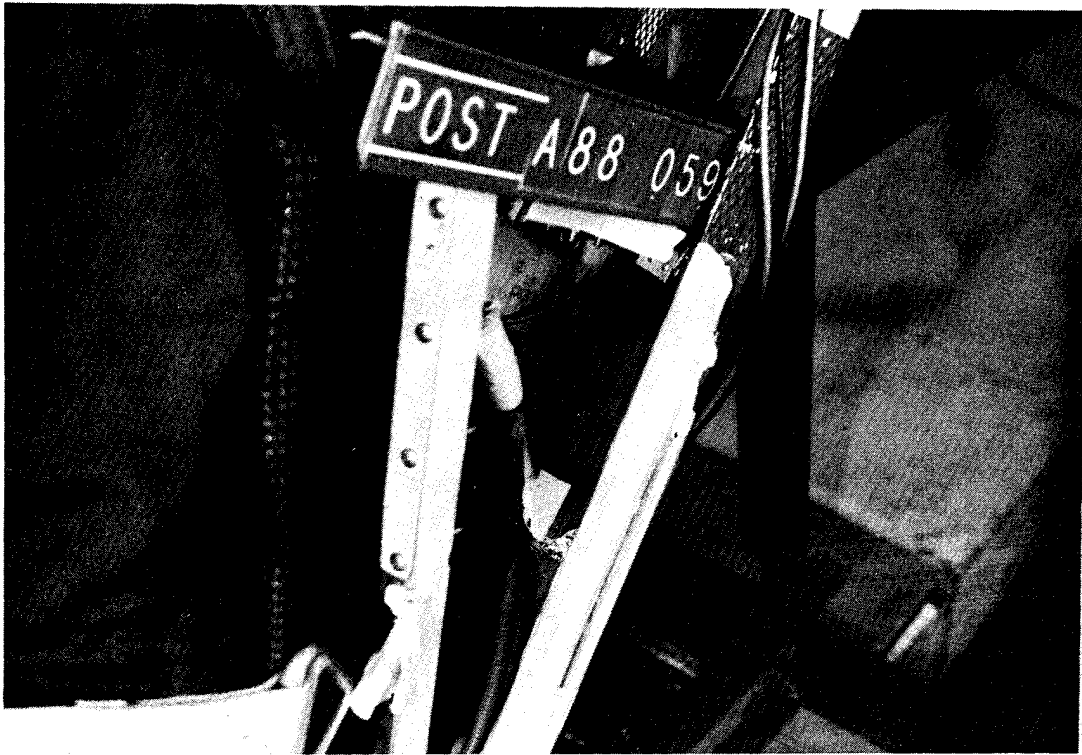
The recorded transducer traces may be reviewed at Figures A-8 through A-11. The seat leading edge bulkhead braces at BL 17.5L, 5.2L, 7.2R, and 20.3R were torn free from their anchorages to the cockpit floor. The failures of these anchorages in the honeycomb floor were photographed and are shown in Figures 23 through 29. The stresses and corresponding loads in the three tubular braces are presented in Figure 17. The brace loads in this test are compared to those from the two pure vertical tests. Note an initial compressive load, due to the downward impact, did not occur in this test, and some tensile load appeared at 34 ms about the same time that the armor plate accelerometers showed deceleration (Figure A-8). The chest X deceleration of the right dummy (Figure A-8) peaked at 24 G, reflecting dynamic overshoot from the 34 G peak sled value acting at 34 degrees from the z-axis. The chest z-value, on the other hand, peaked at only 6 G, a value apparently incompatible with the known 12 G input to the buttocks as indicated by the 1300-lb load shown in Figure A-9. The same chest z-value was correspondingly too low in Figures A-1 and A-4 for tests 88057 and 88058, respectively. The chest z accelerometer appeared to have been inadvertently plugged into the y-axis chest accelerometer. This conclusion is based on the fact that the transducer also read very low negative and positive G in later PDU tests (runs 88060, 88061, and 88062), but when the cockpit was yawed 15 degrees for tests 063 and 064, the z-axis transducer came alive and displayed values of 10 to 15 G as would be expected for the y component. Thus, the chest z values shown are assumed to be chest y values.

The failures of all four brace attachments to the "bathtub" honeycomb floor are depicted in Figures 25-29.

Figure 25. Failure of BL 20.3 right outboard brace tube anchorage to floor.

Since the anchorages did fail after sustaining this force for about 10 ms (Figure 17), we believe only a small strength increase would sustain the test loads. It is suggested the horizontal shear be carried through the honeycomb "bathtub" at the outboard edges of each seat and at the center console web. The cost and weight of a web structure should be lower than the separate bracing tubes.

#6. Delete floor-to-bulkhead braces at BL 17.5L, 5.2L, 7.2R, and 20.3R and replace with horizontal beam between knee bulkhead and FS 73.06 canted bulkhead.	-2.0 (approximately)

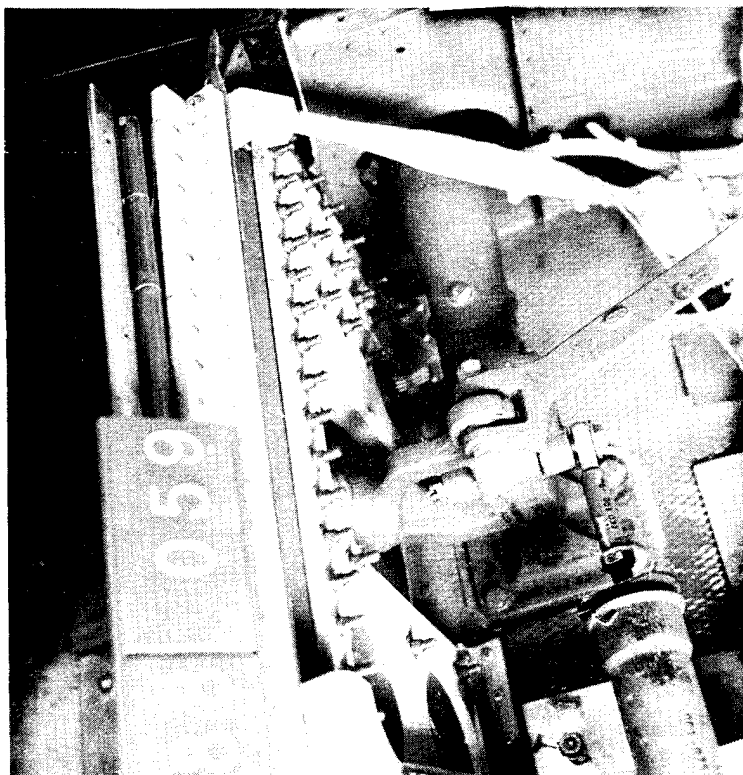
Figure 26. **Posttest view of BL 17.5 left brace and BL 5.2 left brace tube (note slight separation of M535830 hinge at inboard edge).**

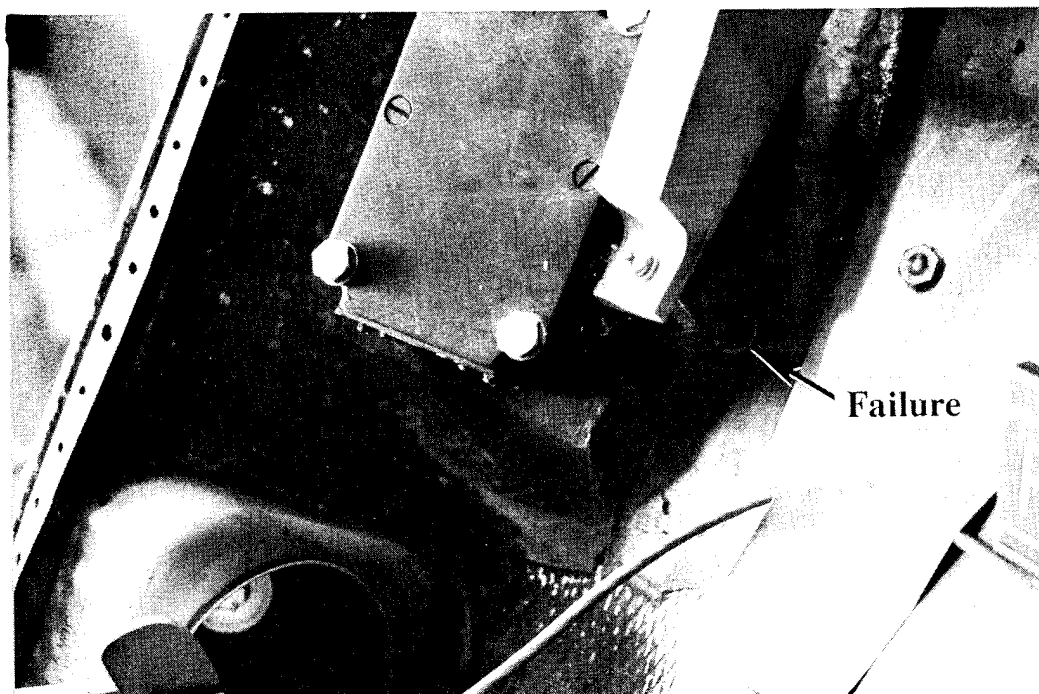
Figure 27. **Failure of BL 17.5 left brace anchorage to floor.**

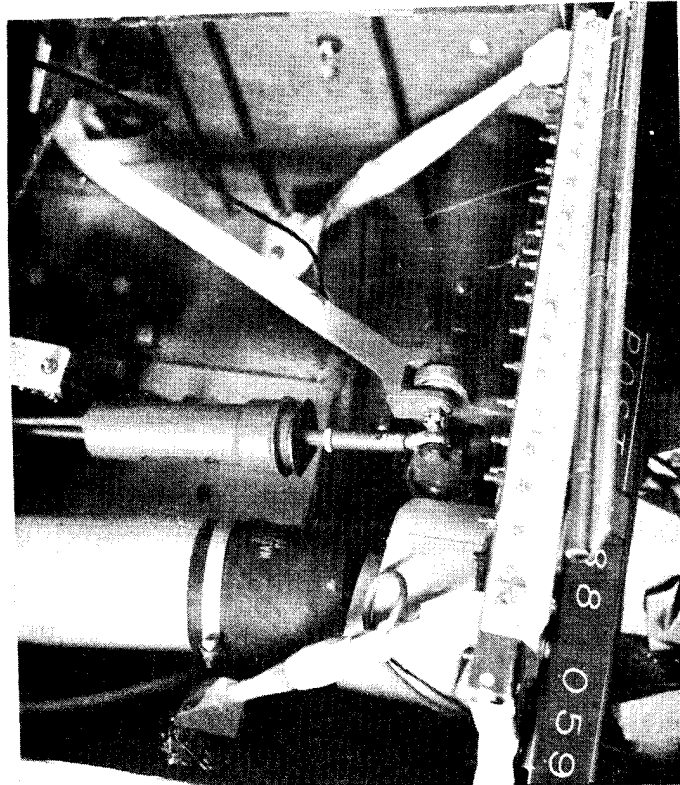
Figure 28. View of right seat area after removal of armor plate at hinge (note separation of M535830 at bottom of photograph).

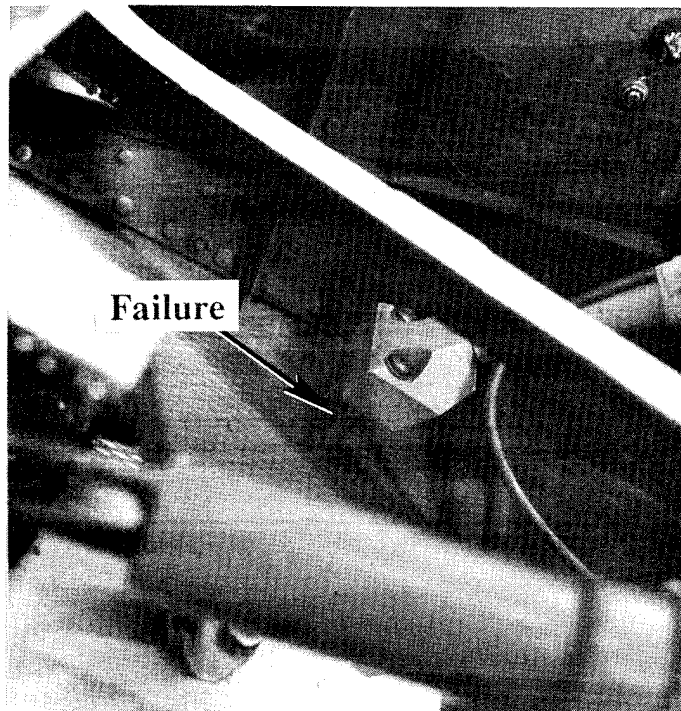
The failure of all four brace anchorages at a horizontal velocity change of only 18 fps and approximately 20 G impact is a point worthy of redesign effort for a production seat. The right inboard (BL 7.2R) anchorage failed at only 1373 lb, little more than half the failure load of the other two tubes at 2203 lb $((2222+2184)/2)$. If failure had not occurred in the right inboard brace, and 2203 lb were sustained in each brace, the horizontal x-axis load would be as follows:

Figure 29. Closeup view of BL 7.2 right anchorage failure at 1373 lb.

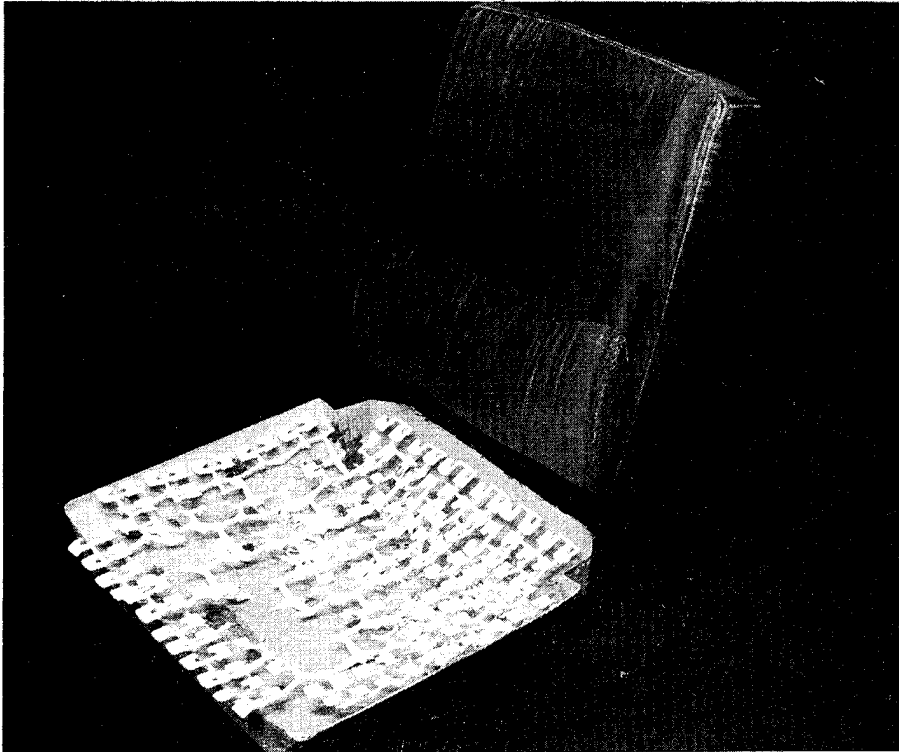
Figure 36a. Copilot seat bottom and back cushions after removal of PREQUAL™ cover after 20 months and 100 flight hours in JOH-58A (Ser 71-20778).

The degraded PREQUAL™ was replaced with foam cushions (cut to size) from wrecked UH-60 seats, and the frayed, worn SPACEFABRIC™ was replaced with black sheepskin covers, also from UH-60 wrecked seats. A recent inspection reveals the seat cushions are still serviceable, but the sheepskin is faded somewhat after 4 years exposure in the JOH-58A. Unless SPACEFABRIC™'s resistance to sunlight is improved, the sheepskin material appears to be a viable candidate to replace it.

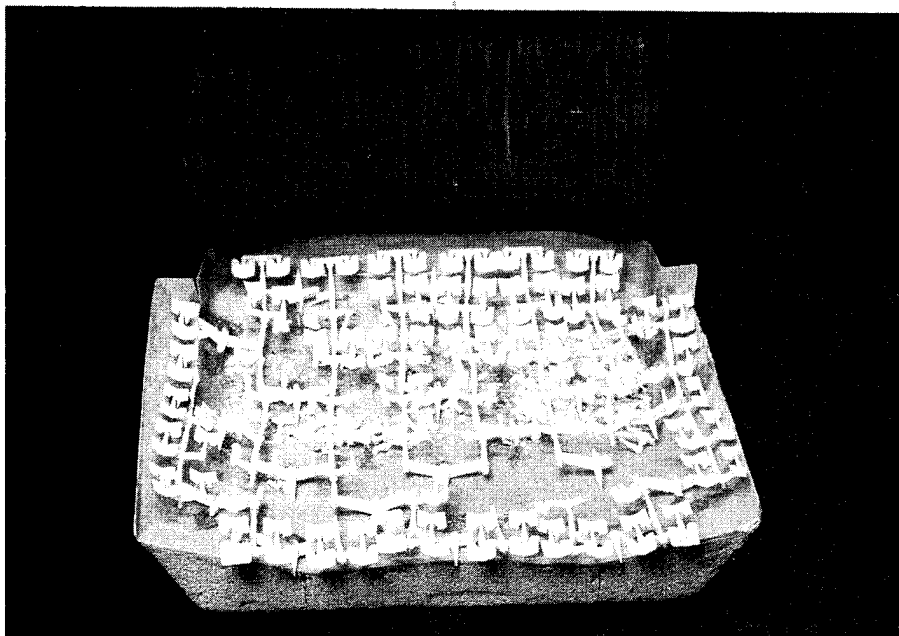
Figure 36b. Copilot (left) seat bottom and back cushions (note disintegrated plastic lever supports).
