UNITED STATES AIR FORCE
AIRCRAFT ACCIDENT INVESTIGATION
BOARD REPORT

F-16C, T/N 87-0315

**194TH FIGHTER SQUADRON
144TH FIGHTER WING
FRESNO ANGB, CALIFORNIA**

DATE OF ACCIDENT: 27 DECEMBER 2012

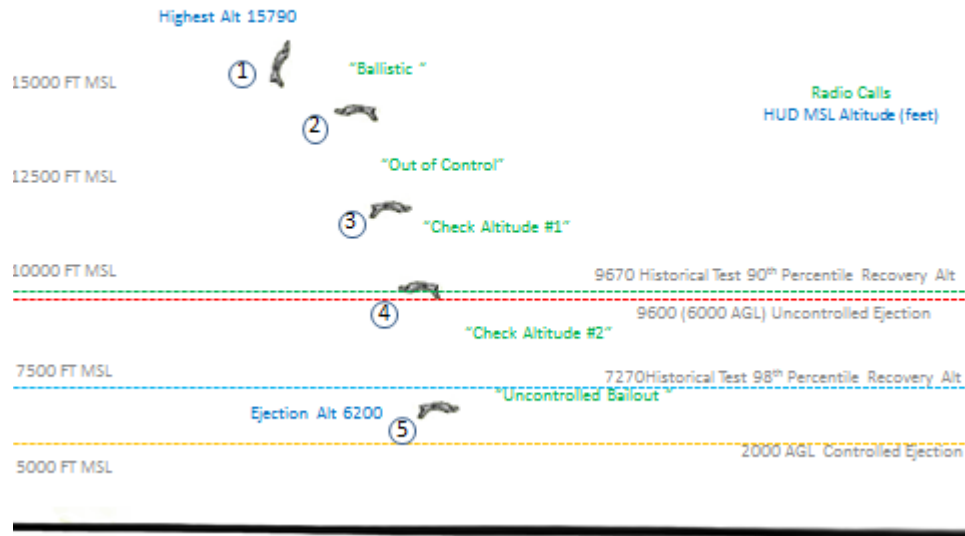
Figure 4.1. Mishap Sequence Profile View (Tab HH-40)
Mishap Sequence Profile View

The MA sliced into an inverted attitude as forward momentum slowed, and entered a negative AOA departure (Tabs J-9 to J-10, HH-9). A departure is defined as a loss of aircraft control characterized by significant, large amplitude, and uncommanded motions (Tab HH-5). The automatic flight control system (FLCS) features of the F-16 normally prevent departures but may be defeated if maneuvering limits are not observed (Tab HH-5). The F-16 depends on its horizontal tails to limit AOA and typically reaches its controllability limit at approximately ± 40 degrees AOA (Tab HH-5). Exceedance of the AOA value is used for departure recognition (Tab HH-5). This type of departure is characterized as a pitch departure, because the inability to control AOA leads to an out-of-control situation. Pitch departures are typically slow speed where the MA is in a nose high pitch attitude. Airspeed is bled off until the ballistic path of the airplane drives AOA to increase quicker than the tail can control due to limited control authority (Tab

Analysis from 416th Flight Test Squadron (FLTS) flight testing provided comparison for departures resulting from the maneuvers performed with similar aircraft configurations to the MA (Tabs HH-6 to HH-7). Out-of-Control Recovery characteristics for maneuvers performed with the wing tank loadings resulted in recovery from all departures within two pitch rocking cycles (Tab HH-6). Historically, during test programs, the 90th percentile altitude lost during recovery is 6100 ft., while the 98th percentile altitude lost during recovery is 8500 ft. (Tab HH-7). Post-maneuver analysis determined insufficient rudder pedal force was applied to counter the yaw rates, and that pitch rocking was not performed in phase with pitch cycles, both of which combined to delay the recovery (Tabs J-10 to J-11, HH-10 to HH-13). Figure 4.1 below overlays the historical 90th and 98th percentile recoveries with the mishap sequence and parameters (Tabs HH-39 to HH-40).
