UNITED STATES AIR FORCE
GROUND ACCIDENT INVESTIGATION
BOARD REPORT

TYPE OF ACCIDENT: ON-DUTY FATALITY
LOCATION: JOINT BASE BALAD, IRAQ
DATE OF ACCIDENT: 15 SEPTEMBER 2010

United States Air Force Ground Accident Investigation Board Report
On-Duty Fatality
Joint Base Balad, Iraq
15 September 2010

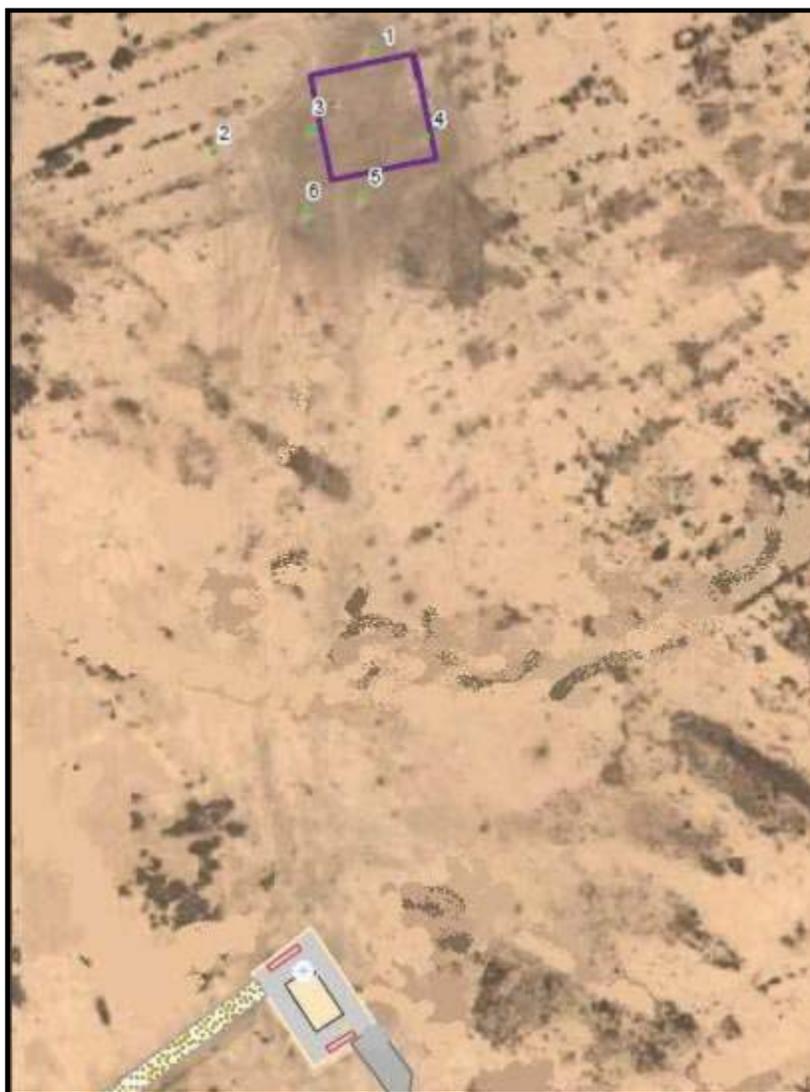
Figure 1: Diagram of EOD Range Structure and Detonation Area

Upon arrival at the range, all personnel received a second safety briefing from EOD, and then were divided into small groups. (Tabs V-12.3, V-13.3, V-47.1) Some EOD members were already on site previous to the observers' arrival and had separated the charges and ordnance between six different detonation sites on the EOD range. (Tabs V-12.3, V-13.3) These detonation sites varied between 90 to 180 feet apart. (Figure 1 below)

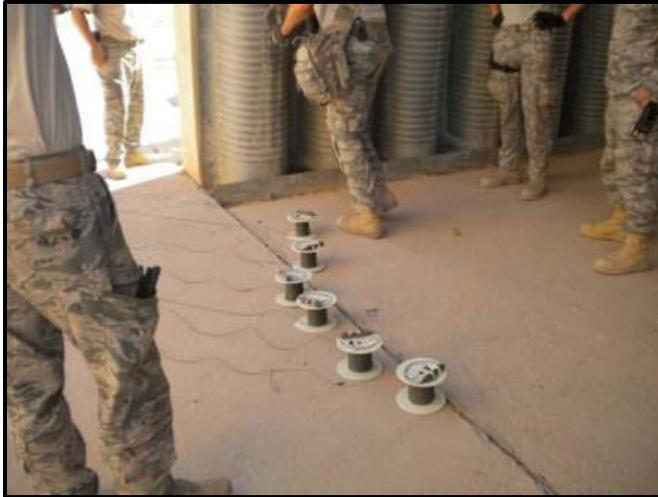
Figure 2: Placement of shock tube and initiators

The EOD members brought the end of shock tube connected to the detonation initiators to an area just under the overhang of the designated safe area in the open space between the concrete wall and the arched shelter. (Tabs V-2.14, V-12.4 – 5, Y-3, Y-4, Y-8) Personnel in this location were in a direct line-of-sight to the demolition set-ups. (Tabs V-12.6, Y-3, Y-4) They were also within the maximum fragmentation range distance and did not have frontal protection against the effects of the explosions (see section 5.2). (Tabs Y-17, Y-18, Y-21, CC-3)

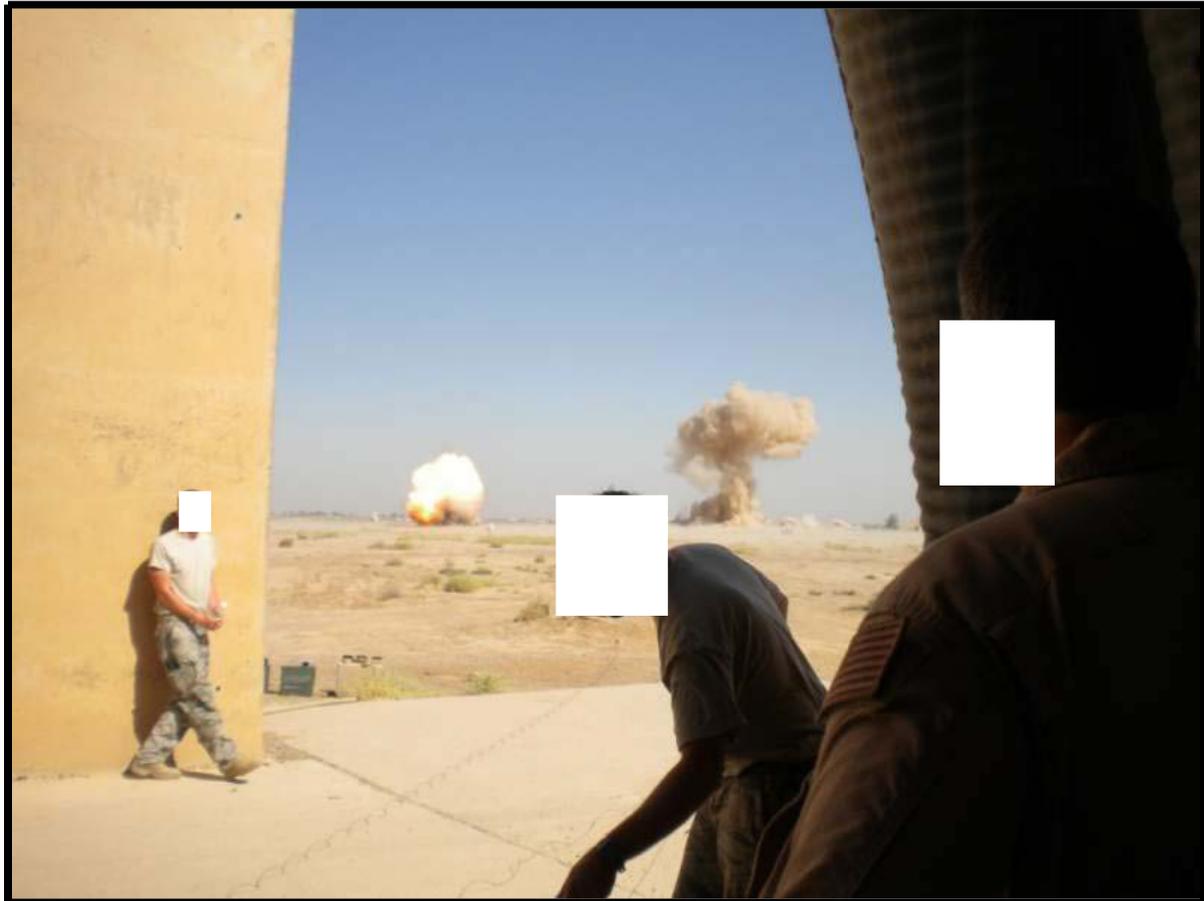
**Figure 4: Observer photo immediately after second detonation
(No casualties appear in this photograph)**

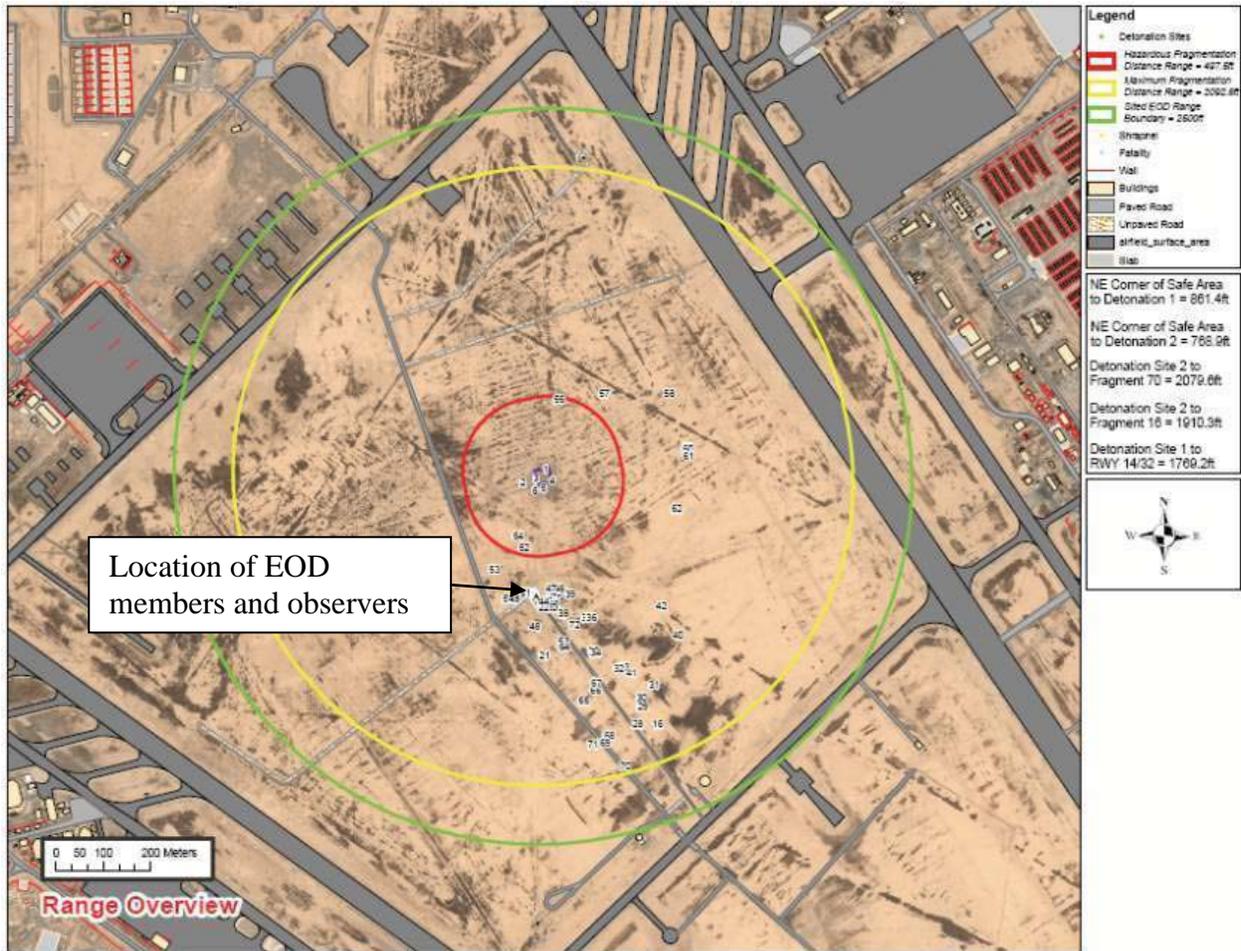
Figure 5: Range Overview

The GAIB plotted the calculated fragmentation distances on a map of the EOD range for a visual representation. The designated safe area from which personnel viewed the detonations was outside of the HFDR (depicted by the red “ring” at 497.51 feet from the detonations in the graphic below) but within the MFDR (depicted by the yellow “ring” at 2,092.48 feet from the detonations) and the EOD range boundaries (depicted by the green “ring” at 2,500 feet from the detonations). (Tab Y-17) Actual fragments from the detonations were plotted on the JBB EOD range by base personnel after the mishap. (Tabs O-33, O-34, O-40, O-41) These fragments were easily distinguished by their distinctive “bluing” effect and the lack of any environmental rusting. The locations of these actual fragments are overlaid on the map as well (depicted by numbers next to small yellow “+’s”) and were consistent with the predictive fragmentation calculations. (Tabs Y-17, Y-21, CC-3 – 4) The EOD members and casual observers were approximately 769 feet from the detonations. They were within both the minimum 1,250 foot distance and the calculated MFDR. When individuals are within the MFDR or within the 1,250 foot distance, they are required to use both frontal and overhead protection. (Tabs AA-28 – 30, AA-34 – 35)

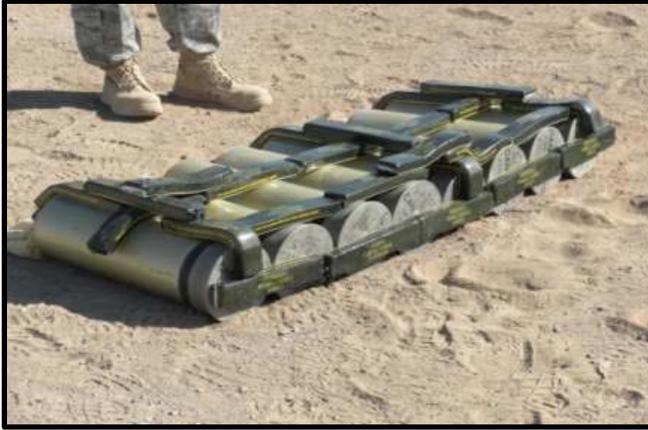
Figure 6: Photo of Detonation 1 Set-Up

The metal bases of the M1028 cartridges prepared for the first and second detonations were oriented towards the general direction of personnel participating in the operation. (Tabs O-29, R-3 – 6, V-2.11, Y-12 – 15, Y-18, Y-25 – 28, CC-3)

The general orientation of the ordnance set-ups prior to the detonations was determined through analysis conducted during a site visit using terrain association in conjunction with available photographs, maps, and a compass. (Tabs CC-3 – 4) The metal case bases of the cartridges were “oriented north/south” toward the general direction of personnel participating in the operation on 15 September 2010. (Tabs O-29, R-22 – 26, V-2.11, V-3.9, Y-12 – 15, Y-18, Y-25 – 28, CC-3 – 4) The plotted fragmentation pattern is consistent with this orientation. In addition, the cartridges prepared for the first and second demolitions were on the surface of the ground instead of a depression at the detonation area. The photographs below show the ordnance and munitions for the first and second detonations as they appeared before EOD members and observers departed the blast area.

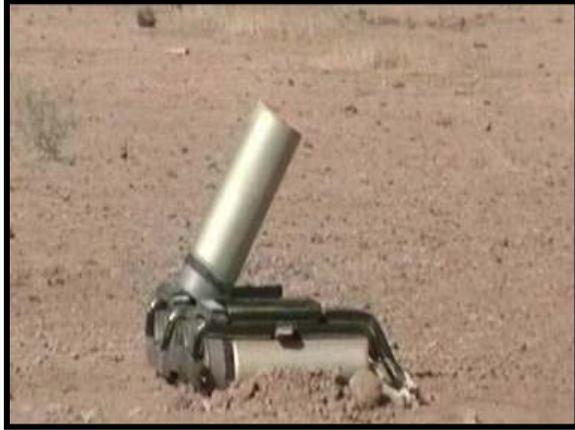
Figure 7: Photo of Detonation 2 Set-Up

In summary, the evidence shows that the metal fragments did not travel farther than the predicted MFDR and primarily traveled in the direction they were oriented. The frontal protection available by the designated safe area on the JBB EOD range is sufficient to protect against the dangers associated with such fragments. (Tabs Y-7, AA-30)

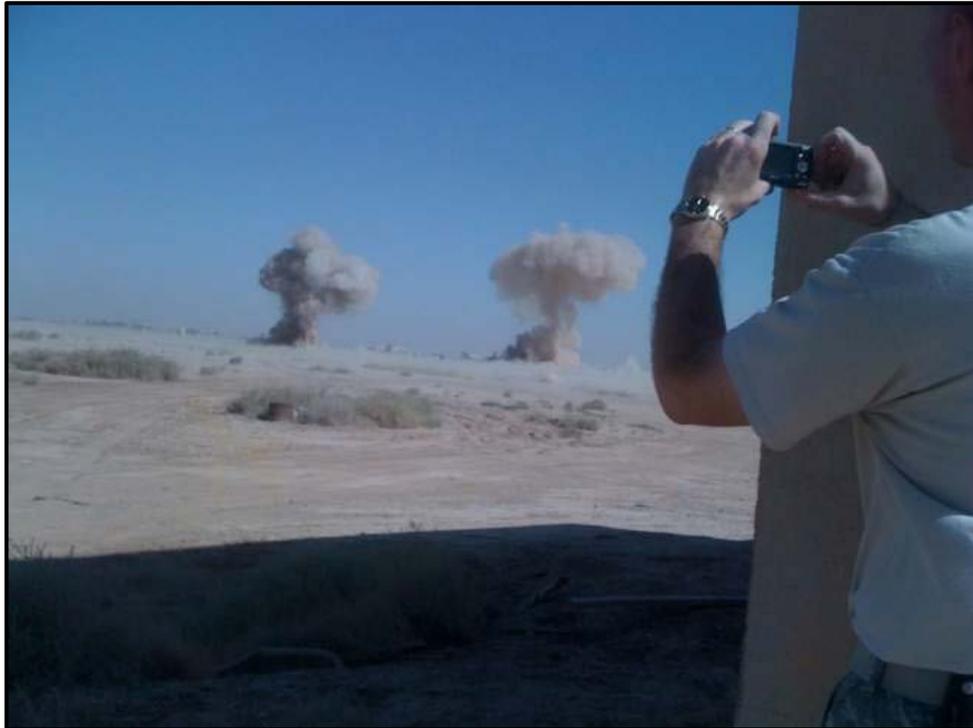
Figure 8: Photo by observer from west side of structure

AFMAN 91-201 (Explosive Safety Standards) paragraph 12.74.4., Technical Order (T.O.) 60A-1-1-4 (Protection of Personnel and Property), and the 332 ECES EOD FOI 32-3002 all require the maximum protection to personnel from the potential dangers from ammunition and explosives. (Tabs O-12, AA-15, AA-28, AA-34 – 35) On the day of the mishap, several personnel—both EOD technicians and casual observers—were in direct line-of-sight of the detonations. (Tabs V-1.12, V-2.20, V-3.7, V-12.4 – 5, V-13.12, V-14.8, Y-5, Y-6) The photograph below shows that several observers did not have either frontal or overhead protection during the detonations.

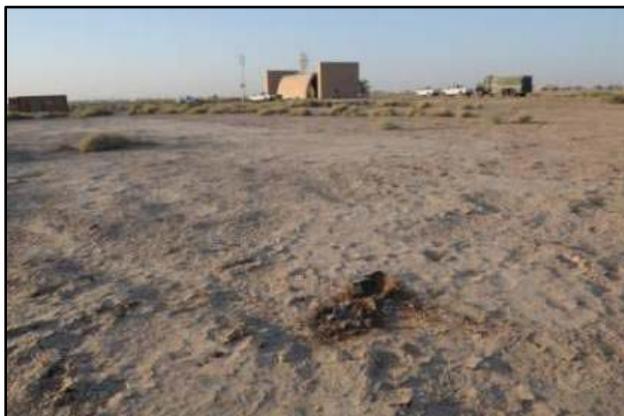
Figure 9: View of Structure from Direction of Detonations

There is a structure located on the EOD range, which is used for personnel protection from the effects of explosions, such as blast overpressure and fragmentation hazards. This structure consists of an arched concrete shelter located on a concrete pad with additional walls on the opposing open ends of this arched shelter. Walls are constructed of heavily reinforced concrete, 47 inches thick. This structure was built prior to U.S. forces residing in JBB. While not oriented optimally (walls not perpendicular to detonation sites) and not specifically designed to provide frontal and overhead protection against effects of the explosions, the local EOD designated safe area does provide protection from the explosive effects of detonations to personnel positioned entirely behind and underneath the walls and roof. (Tabs Y-5 – 7, Y-17, AA-4, AA-15, AA-29 – 30) However, the angle of the structure allows for individuals located in certain sections (northeast side) to be in direct line-of-sight to the detonation site with no frontal protection.
