UNITED STATES AIR FORCE
AIRCRAFT ACCIDENT INVESTIGATION
BOARD REPORT

TARS, T/N 4222
LAJAS, PUERTO RICO

LOCATION: LAJAS, PUERTO RICO
DATE OF ACCIDENT: 16 AUGUST 2011
BOARD PRESIDENT: LT COL BRENDAN O'BRIEN
Conducted IAW AFI 51-503, *Aerospace Accident Investigations*

**SUBJECT: Accident Investigation Board Report: TARS, T/N 4222, Lajas, PR,
16 August 2011**

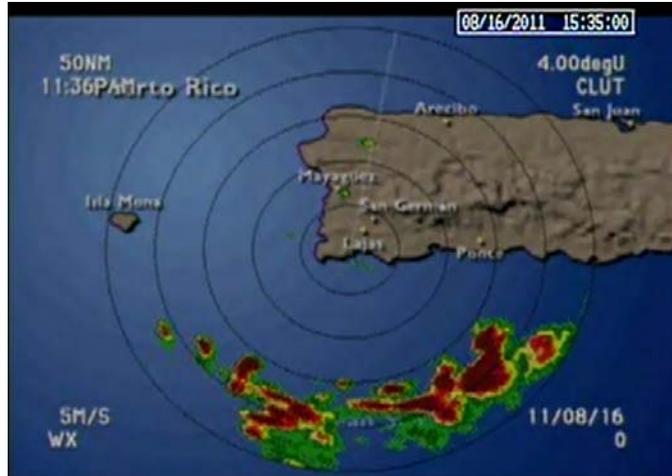
Figure 3. Doppler radar at 15:35:00Z

The Doppler radar pictures and wind data indicate a tropical wave 30nm to the south of the Lajas TARS site at 1535Z, moving WNW. (Tab W-9) At 1556Z, sea breeze thunderstorms developed along the coast in the vicinity of Ponce, Puerto Rico and the tropical wave was now on a NW track with the leading edge of thunderstorms now just outside 20nm, indicating a wave speed of movement of 35kts. (Tabs W-3, W-9)

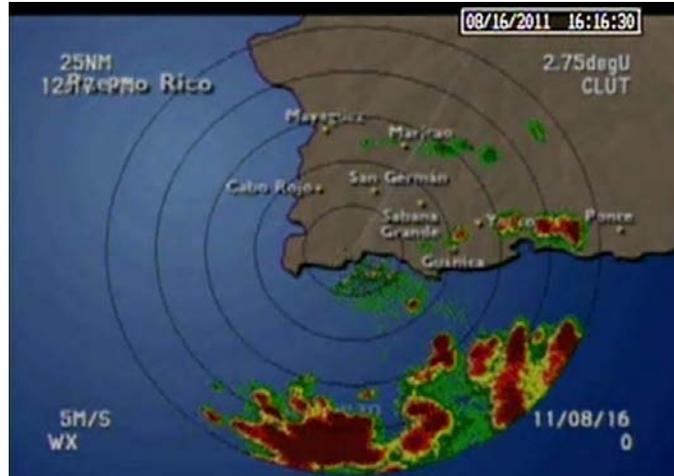
Figure 5. Doppler radar at 16:16:30Z

From 1616Z to 1637Z, the tropical wave continued to track NW towards the site, at speeds of at least 35 knots. At the same time, sea breeze thunderstorms continued to dissipate and develop to the east of the site, tracking W towards the site. (Tabs W-3, W-11 to W-13)

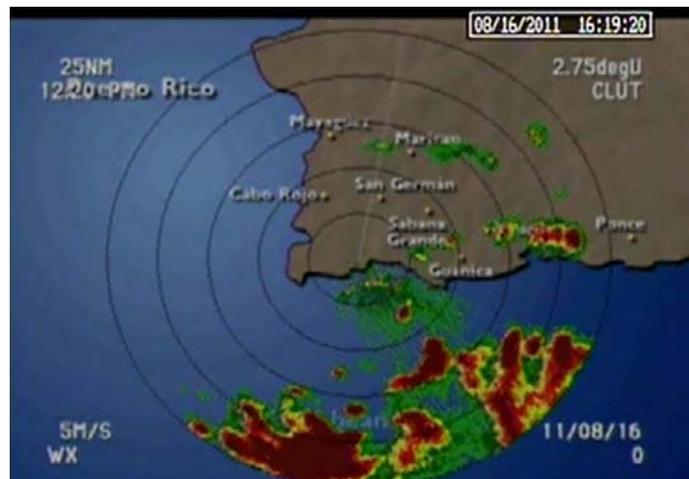
Figure 6. Doppler radar at 16:19:20Z

The combination of the tropical wave storm cells and sea breeze storm cells developing and dissipating rapidly created numerous outflow boundaries (the leading edge of gusty, cooler surface winds from thunderstorm downdrafts) to the E and SE of the site, with outflow speeds reaching as high as 30 knots in all directions. These numerous outflows contributed to the development of new cells. (Tab W-4)

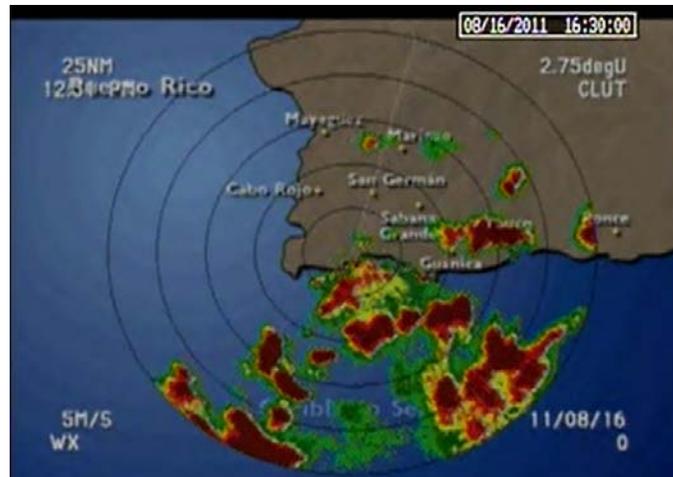
Figure 7. Doppler radar at 16:30:00Z

At 1637Z, numerous cells from the tropical wave were overhead and the nearest sea breeze cell was 10nm to the ENE. Additionally, the outflows interacted with land, giving a large boost to upward development resulting in numerous new storms along the coast. (Tabs W-4, W-14)

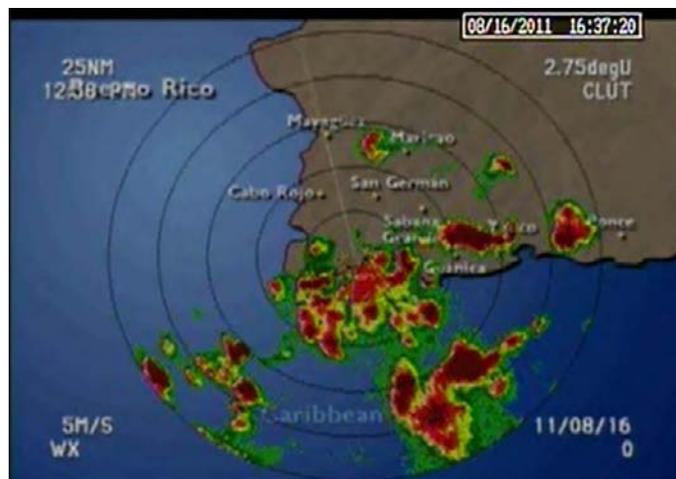
Figure 8. Doppler radar at 16:37:20Z

The tropical wave direction of movement tilted more E to W than previous, which would have added slight rotation to the storms but would not likely have triggered any kind of tornadic activity. (Tab W-4) The observed surface winds of greater than 35 knots and winds aloft greater than 50 knots are a rare occurrence in Puerto Rico. According to the 14WS, both of these occur less than 0.01 percent of the time. (Tabs W-5, W-7)
