Evaluation of a Retrofit OH-58 Pilot's Seat to Prevent Back Injury

Joseph L. Haley, Jr.
COBRO Corporation

December 1994

United States Army Aeromedical Research Laboratory
Fort Rucker, Alabama 36362-0577

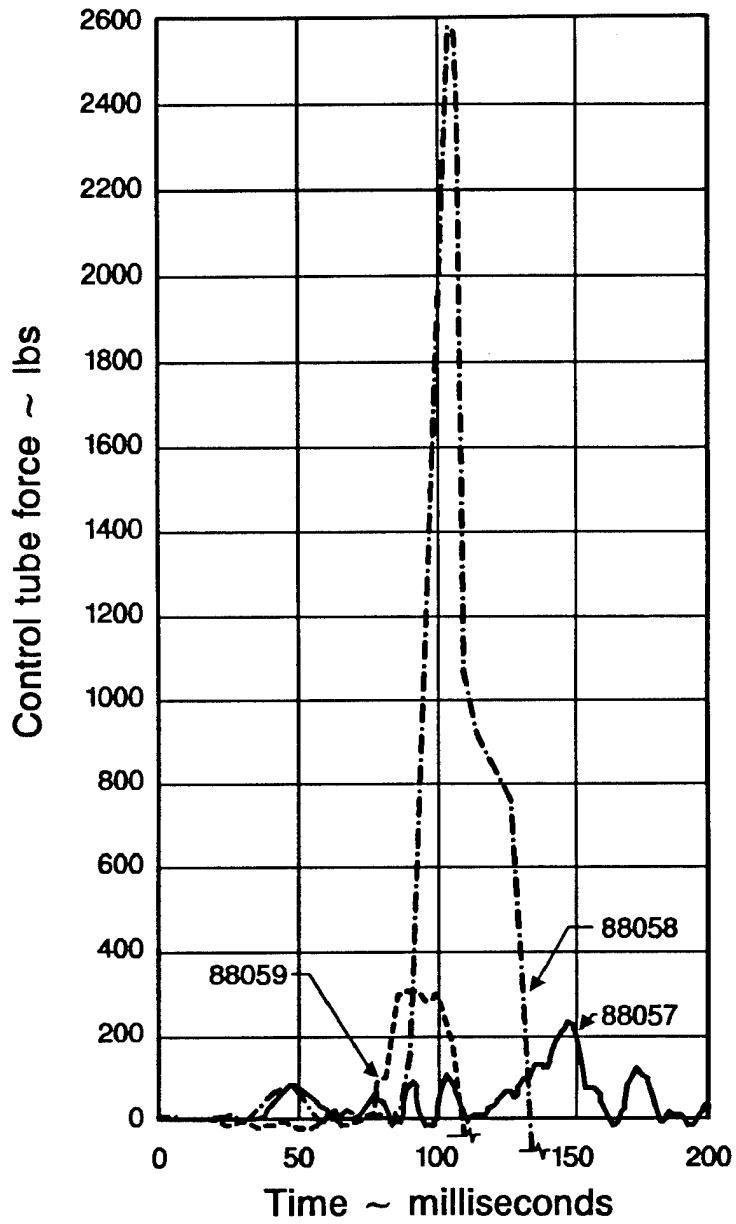
Figure 15. Load cell force measured due to impact of the pivoting seat pan with the under-seat control yoke (see Figures 4 and 23).

Reference to Figure 15 shows the control tube force increased about 1 ms sooner than in test 88057, probably due to the lesser stroke available before yoke contact as shown in Figure A5 in the 82-85 ms time frame. Figure A5 also shows the right seat dummy's lumbar load cell overshoot from 1100 to 2125 lb between 85 and 95 ms, and Figure A4 shows both vertical seat pan transducers producing values of 30 and 45 G at about 92 ms. The control tube force peaked at 2590 lb at 104 ms, and then returned to zero at 134 ms, just about the time the left seat lumbar G value reduced to zero.

The control yoke was impacted at 76 ms as seen in Figure 15, but the control tube load cell sustained only 300 lb at 85 ms; this force was caused by the left dummy deceleration peak of 53 G at 82 ms (Figure A-10). Figure A-9 shows the left seat stroked beyond 5 inches at 80 ms, but "overran," as discussed already. Evidence of the left armor plate impact with the control yoke is shown in Figures 23 and 24. The control yoke was deflected approximately 1.5-inch after impact by the left armor plate, but the right armor plate only touched the yoke with no significant force transfer.

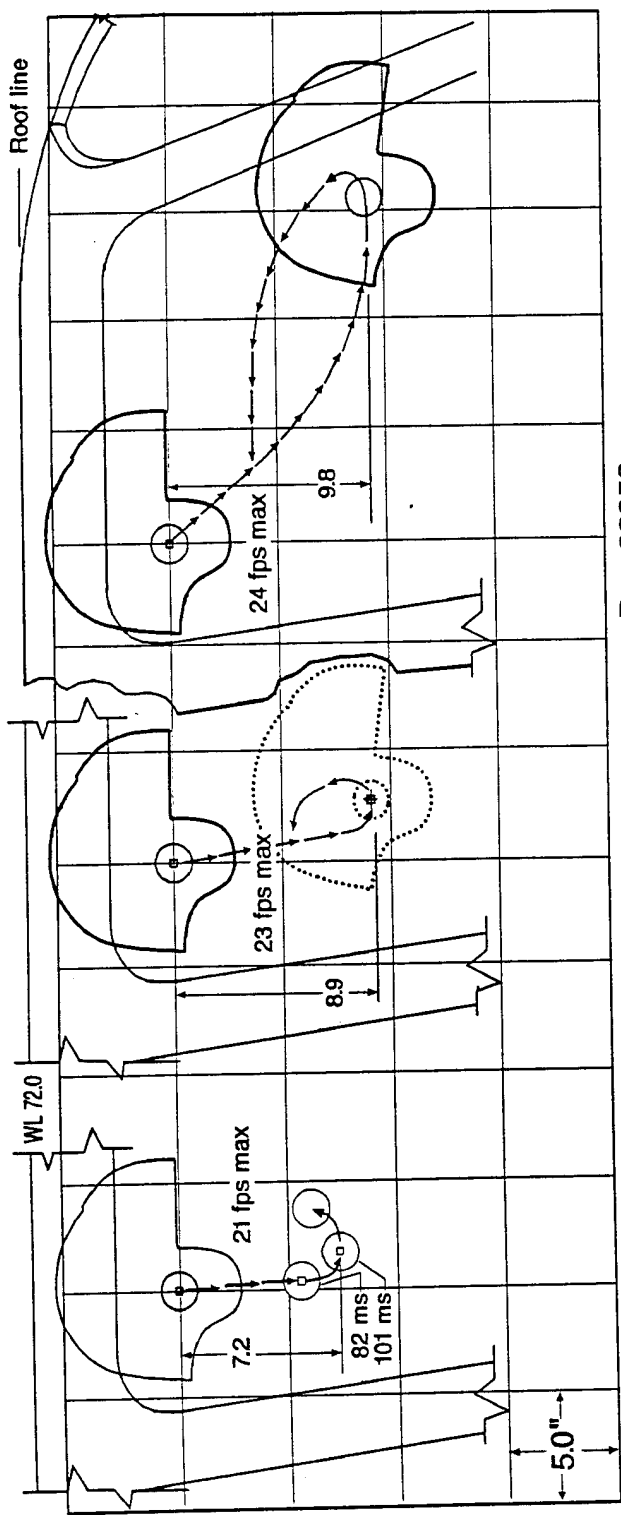
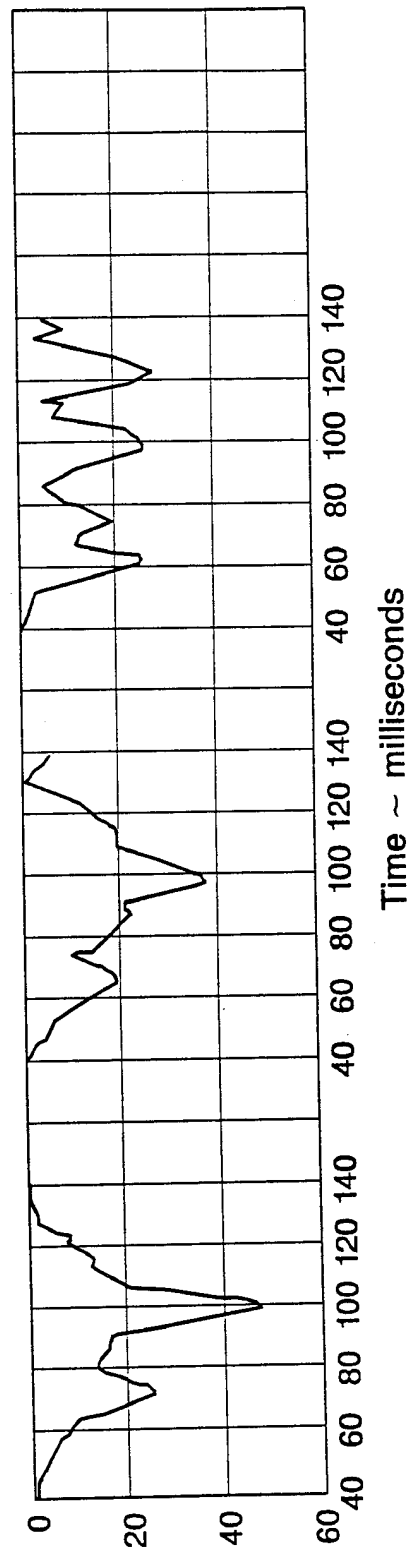
Figure 16. Measured helmet movement of right side dummy from film analysis and head deceleration (runs 88057, 88058, and 88059).

Again, film analysis of this test showed more downward movement of the helmeted head in Figure 17 than shown in Table 3 ($8.90'' - 4.82'' = 4.08''$). Although load-compression data for the seated 50th percentile dummy was not available for analysis, it is assumed the 4.08 inch compression occurred as was estimated in test 88057, except that incremental values were about 60 percent greater. The significance of this considerable compression in the dummy and seat cushion is the stored energy which tends to propel the dummy upward after the impact. The rebound webbing, shown in Figures 4 and 5, permitted the armor plate to rebound about 40 percent of the stroke as noted by Fox in BHT Report no. 699-099-286, pages 4-14. Fox also noted the spring-loaded cam on the webbing slide needed more pressure against the webbing, and the 2-foot long yoke beam, deflecting 1.4-1.6 inch, served as a flat spring being struck near its center; the writers concur with the BHT comments.

The movement of the helmeted head of the right dummy was analyzed from the two cameras on the right; the movement is illustrated to 1/8 scale in Figure 16. Note the 16-inch forward and 9.8-inch downward movement of the helmet even with a properly locked inertia reel, i.e., less than 3 inches strap movement from the reel.

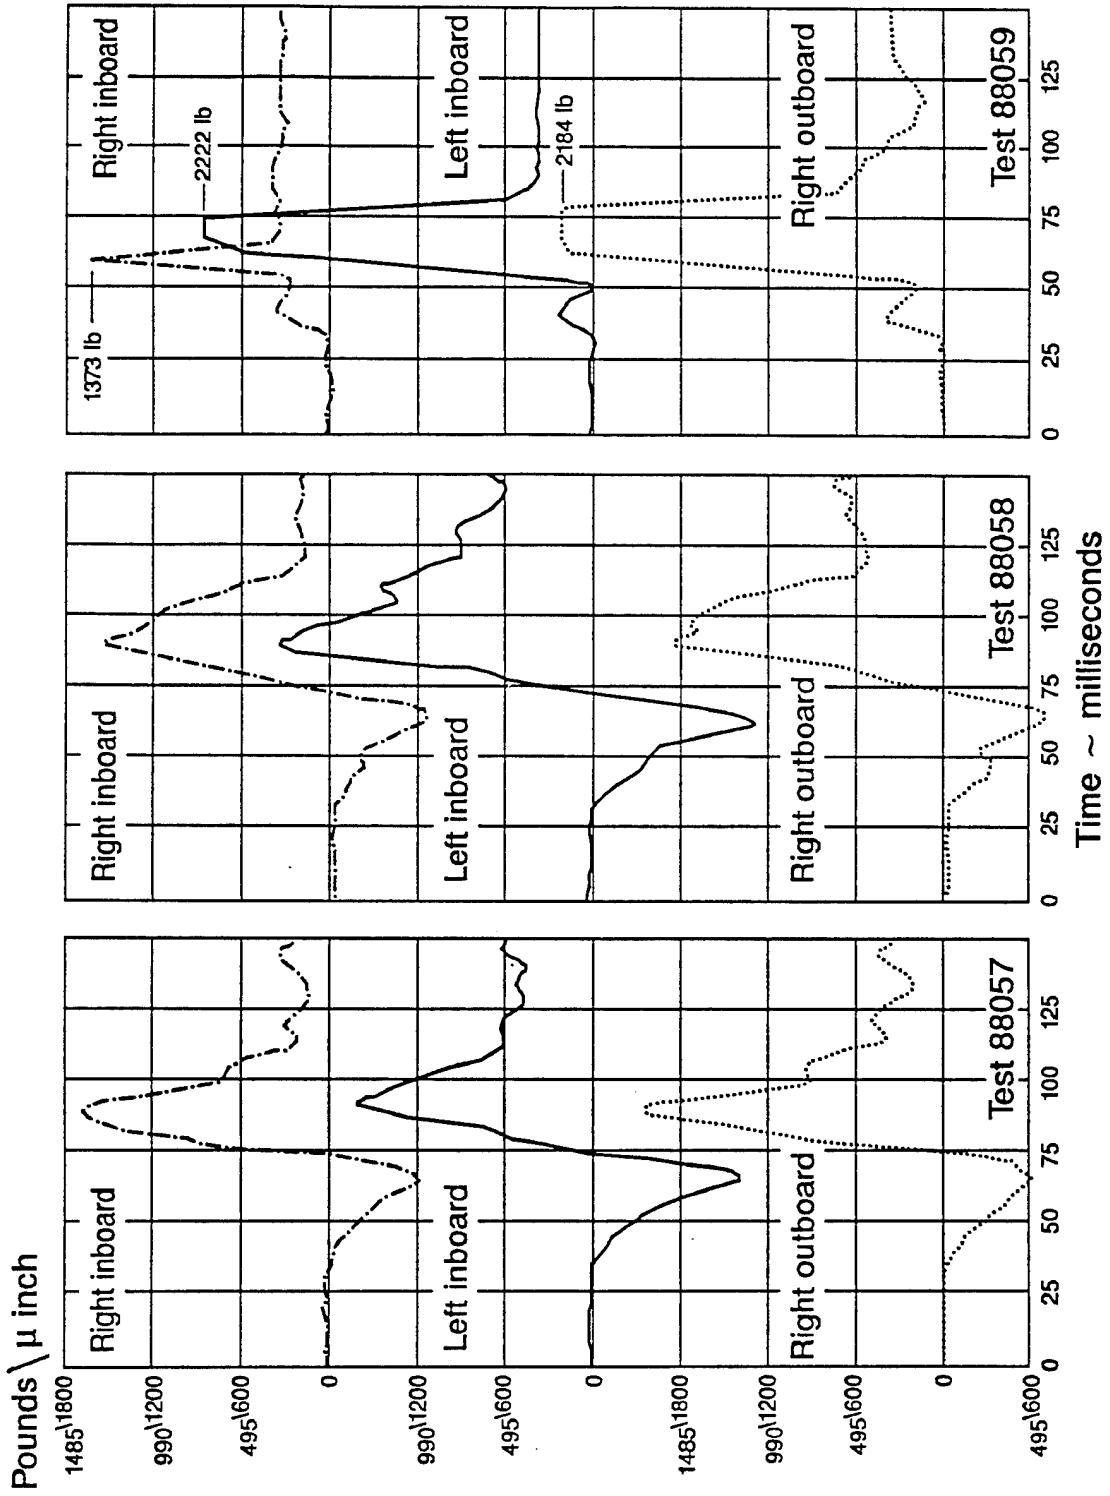
Figure 17. Measured axial strain in aluminum bracing tubes and calculated loads.

Thus, the above load is equal to each 600-microinch increment of strain in Figure 17 where all three bracing tube traces are shown on a common time base and all three tests are shown together. Observe the similarity of the load versus time variation of the three brace tubes; at 32 to 35 ms, all show a compressive load increasing to 500 lb each on the right seat, and 840 lb for the inboard brace of the left seat. The peak compressive load occurs exactly at 67 ms, then reduces to zero at exactly 74 ms, and continues to increase to a peak tensile load at 90 ms on the right seat with medium-size dummy and at 92 ms for the left large dummy. The 2-ms lag of the left seat also may be observed in the seat pan acceleration (Figure A1) in which the peak negative G of 20 and 22 G (left and right) begin to decrease at 103 and 101 ms. The right seat, right tube sustained 1735 lb compared to 1368 lb in the left; this difference would be expected since the center line of the right seat lap belt anchors is located about 0.7-inch outboard of the brace tube center line at BL 13.75R. The load in all three tubes reduces from their peak values to 500 lb or less at 117 ms; from 117 to 150 ms, the left seat sustains the load longer than does the right seat. This same extended time rebound force also is apparent in the left seat tube in the next two tests (88058 and 88059).

Since the anchorages did fail after sustaining this force for about 10 ms (Figure 17), we believe only a small strength increase would sustain the test loads. It is suggested the horizontal shear be carried through the honeycomb "bathtub" at the outboard edges of each seat and at the center console web. The cost and weight of a web structure should be lower than the separate bracing tubes.

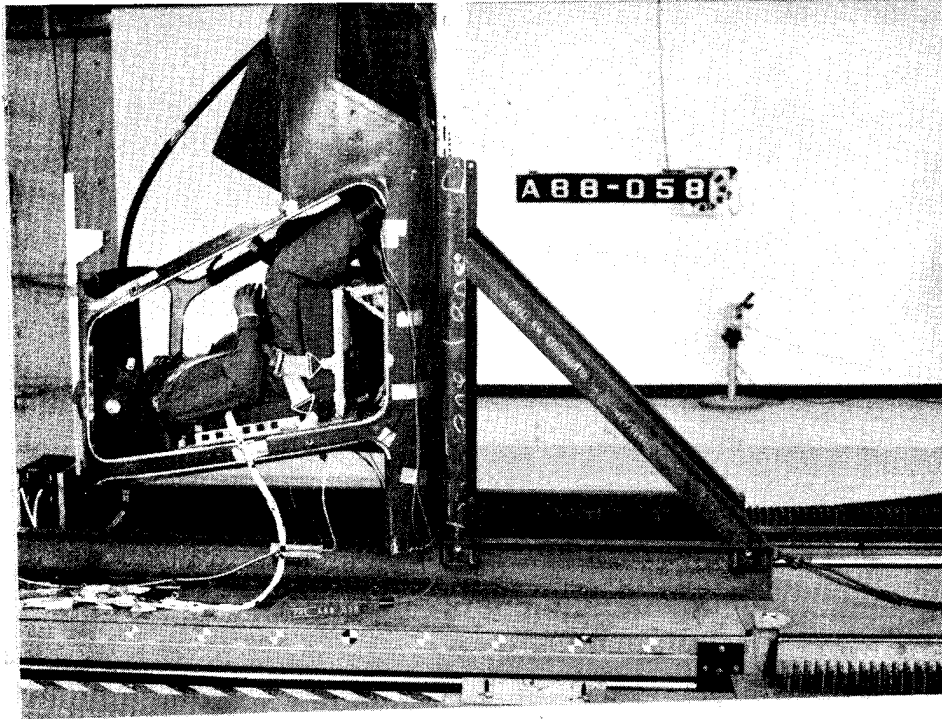
Figure 18. Pretest view of test 88058 (note added beams below nose to stiffen the fuselage).

The only difference in this test and test 88057 was the increased velocity to 29.6 fps from 26.5, and the collective control being placed in the "full down" position yielding about 1 inch less available stroke before under floor yoke contact. Pre- and posttest photographs from the right side are at Figures 18 and 19. A posttest view from the left side is at Figure 20. All transducer traces for the test are at Figures A4 through A7.

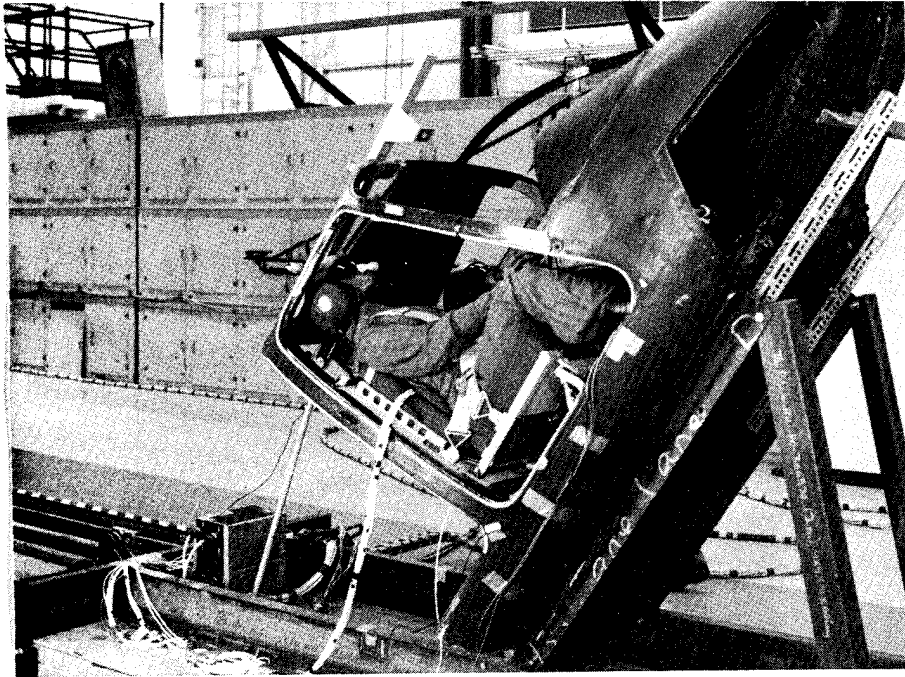
Figure 21. Pretest view of test 88059 (note the fuselage is pitched 56 degrees from vertical in lieu of 90 degrees).

Pre- and postimpact photographs are at Figures 21 and 22. The steel tube running from the sled to the fuselage ceiling is shown clearly in Figure 22. This tube was intended to prevent horizontal shear deformation in the fuselage due to the horizontal crash loads.

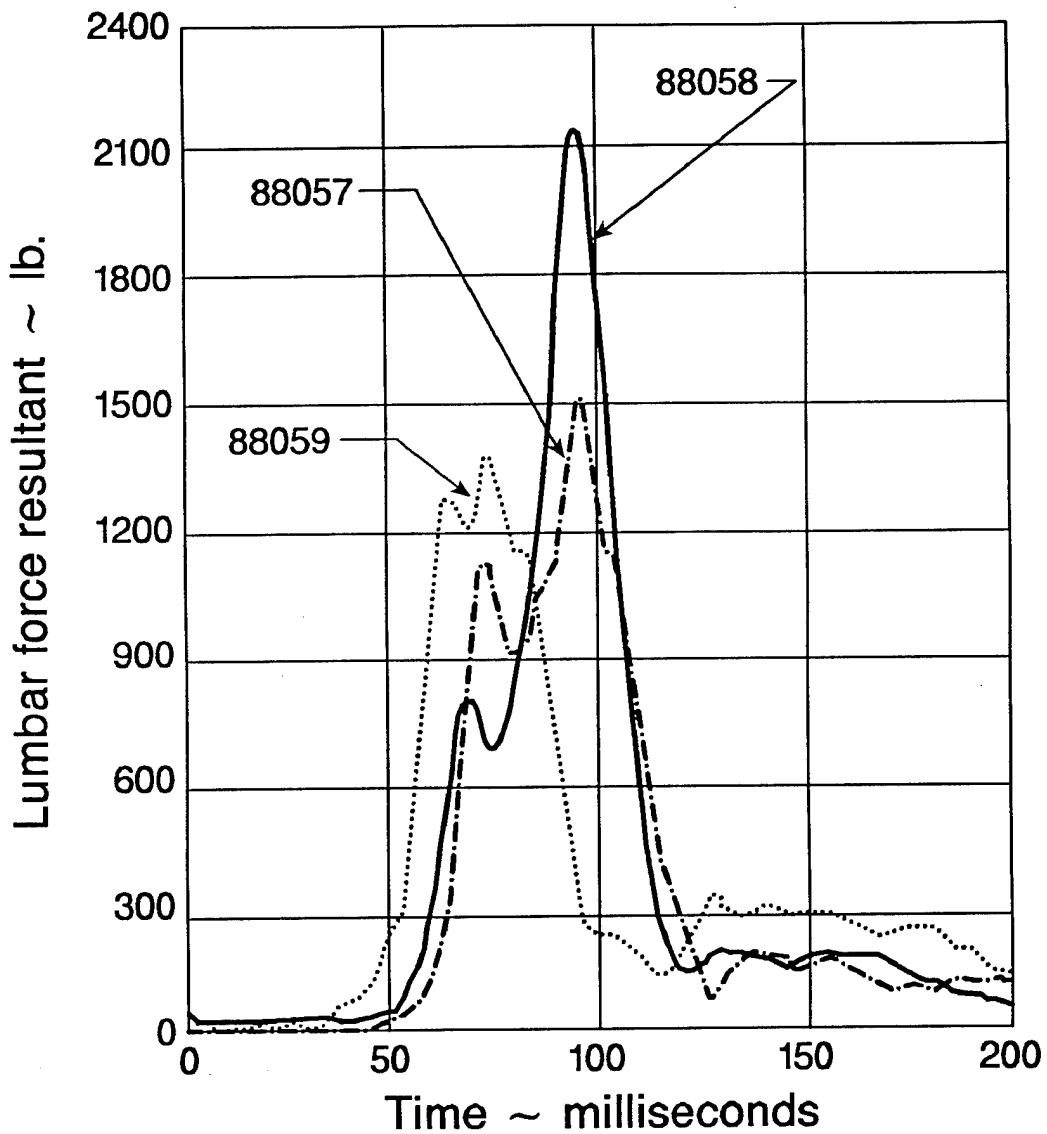
Figure 30. Calculated resultant of X, Y, and Z lumbar load cell vectors in right dummy.

This was a successful test series both in terms of collecting pertinent transducer data and in the performance of the crashworthy seats. The key transducer to determine the seats' ability to "limit" load were the L4-L5 lumbar load cell in the right dummy, and the load cell output along the x-, y-, and z-axes are recorded at Figures A-2, A-5, and A-9. The x, y, and z resultant loads from all three tests are presented in Figure 30. Note the load was "limited" at about 1100 lb in test 88057, then peaked to 1500 lb. In test 88058, the excess energy caused the pivoting armor plate to impact the control yoke and peak at just over 2100 lb. In test 88059, the vertical (z-axis) velocity was about equal to that of test 88057, and the load was again "limited" to about 1150 lb over a time span of 25 ms. Although the right seat pan did impact the yoke in test 88059, it is

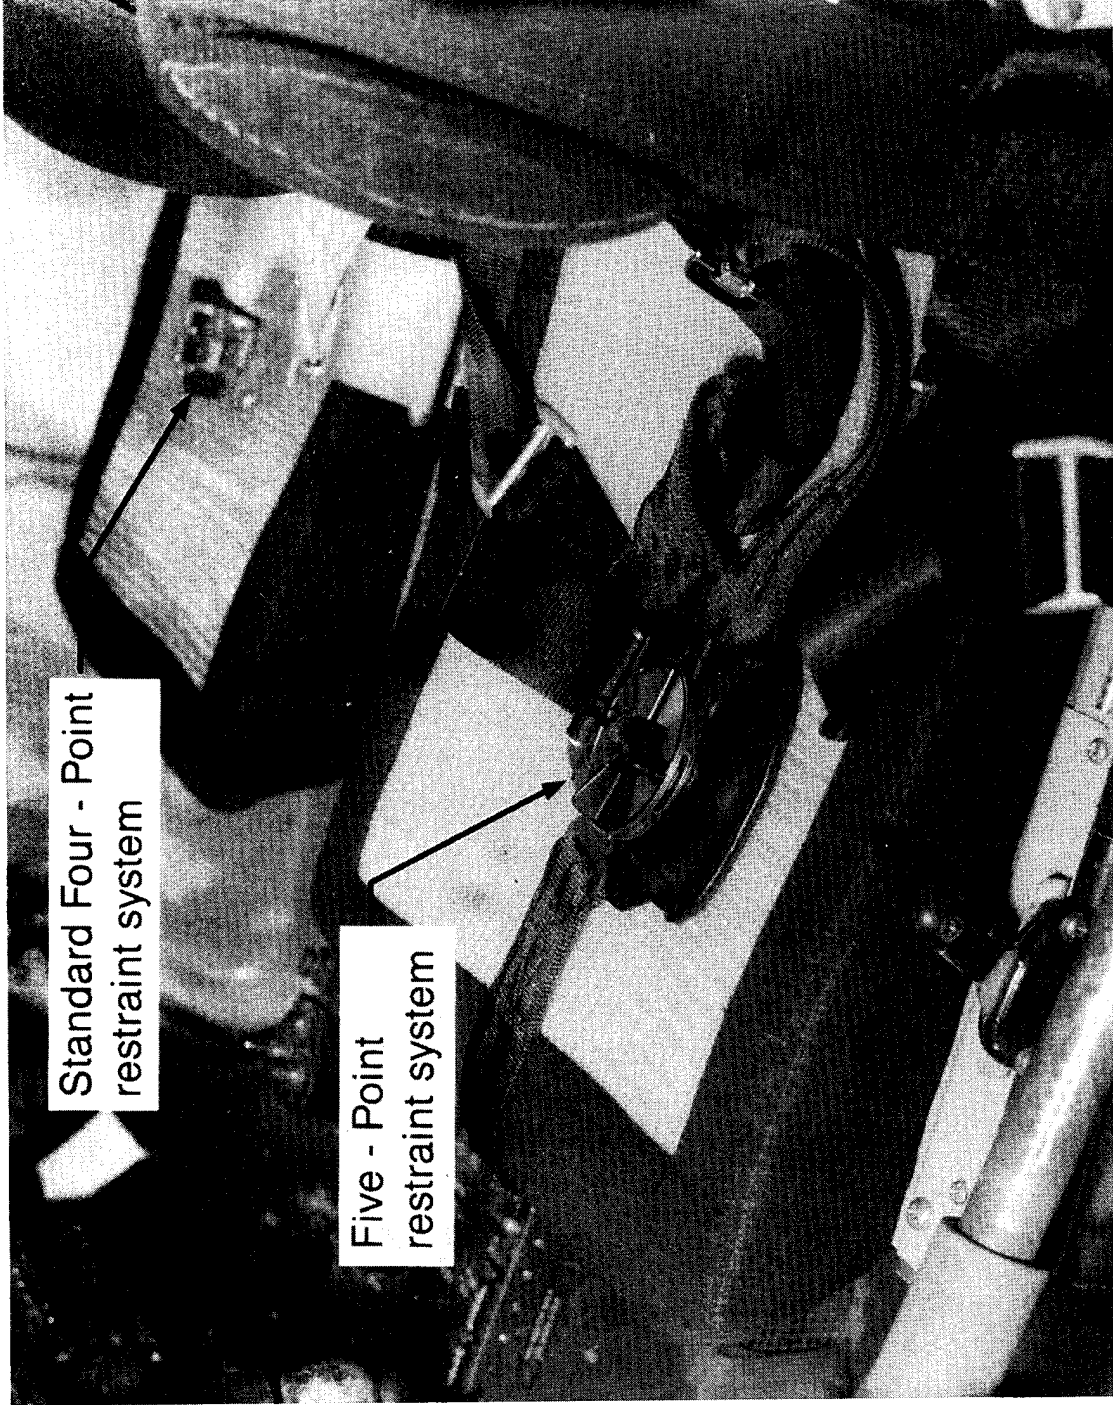
Figure C-1. The crashworthy seat and five-point restraint system (from TECOM #4AI-130-58A-023).
