UNITED STATES AIR FORCE
AIRCRAFT ACCIDENT INVESTIGATION
BOARD REPORT

TARS, T/N 4220
MARFA, TEXAS

EXECUTIVE SUMMARY
AIRCRAFT ACCIDENT INVESTIGATION
TARS, T/N 4220, Marfa, Texas
14 February 2012

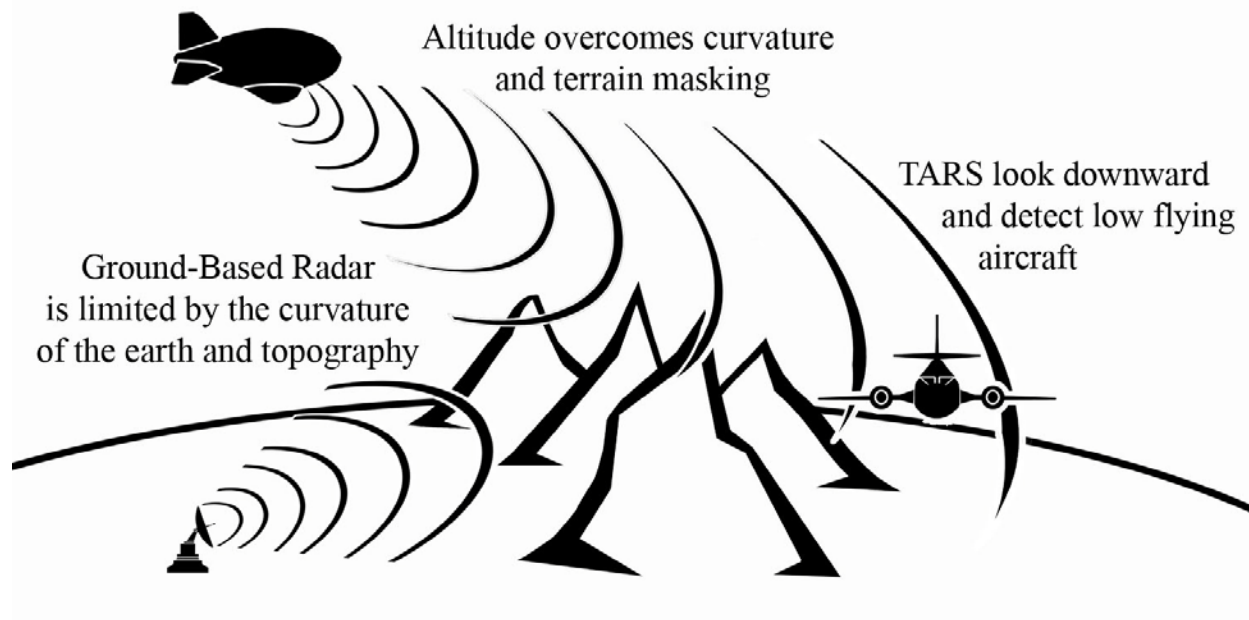
Tab U-328

The TARS is an aerostat-borne, surveillance program (Tab CC-3). Using the aerostat as a stationary airborne platform for surveillance radar, the system is capable of detecting low-altitude aircraft at the radar's maximum range by mitigating curvature of the earth and terrain masking limitations (Tab CC-3). The TARS provides detection and monitoring capability along the U.S.-Mexico border, the Florida Straits and a portion of the Caribbean in support of the Department of Defense Counter-drug Program (Tab CC-3). The primary agencies using the TARS surveillance data include U.S. Northern Command in support of Customs and Border Protection (Air and Marine Operations Center and Caribbean Air and Marine Operations Center) and U.S. Southern Command in support of Joint Interagency Task Force-South (Tab CC-3). In addition to its counter-drug mission, TARS surveillance data also supports North American Aerospace Defense Command's air sovereignty mission for the continental United States (Tab CC-3).

The TARS consists of four major parts: the aerostat and airborne support equipment, the radar payload, the tether and winch system, and the ground station (Tab CC-3). The aerostat used on the TARS program is a large fabric envelope filled with helium and air (Tab CC-3). The hull of the aerostat contains two chambers separated by a gas tight fabric partition. The upper chamber is filled with helium, which provides the aerostat its lifting capability and the lower chamber is a pressurized air compartment (air ballonet) (Tab CC-3). The aerostat hull is constructed of a lightweight Tedlar fabric that is resistant to environmental degradation, minimizes helium
