UNITED STATES AIR FORCE
ABBREVIATED AIRCRAFT
ACCIDENT INVESTIGATION
BOARD REPORT

MQ-1B T/N 07-3220
57TH WING
NELLIS AIR FORCE BASE, NEVADA

LOCATION: ISLAMIC REPUBLIC OF AFGHANISTAN
DATE OF ACCIDENT: 14 APRIL 2012
BOARD PRESIDENT: LIEUTENANT COLONEL BRETT M THOMAS
Conducted IAW Air Force Instruction 51-503
Abbreviated Accident Investigation pursuant to Chapter 11

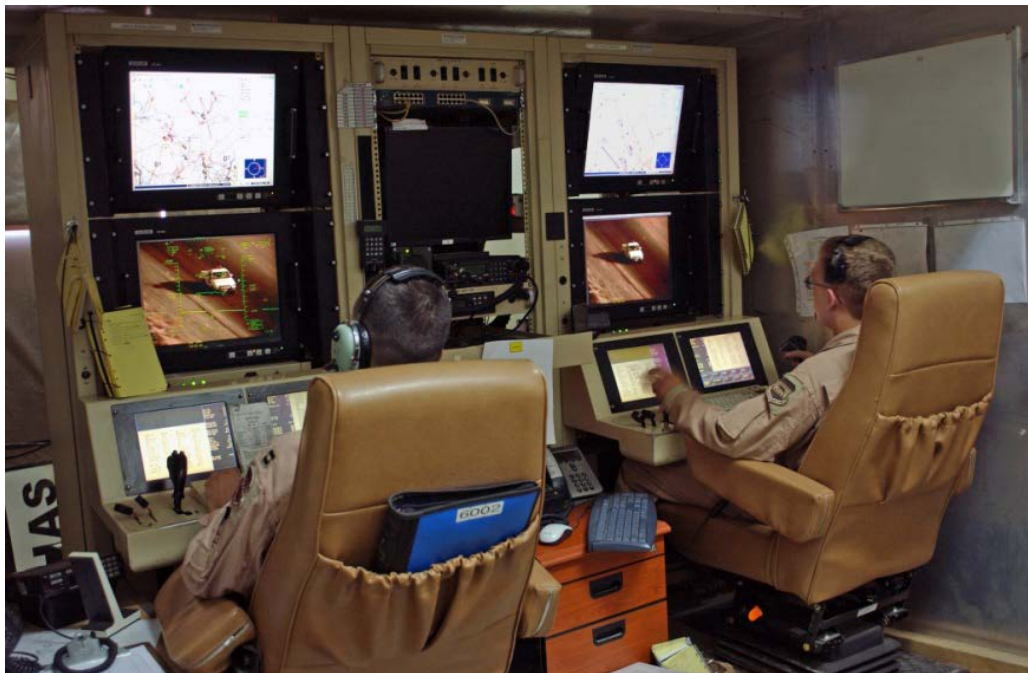
Figure 2. Inside View of Ground Control Station (Tab CC-3)

The basic crew for the Predator consists of a pilot to control the aircraft and command the mission and an enlisted aircrew member to operate sensors and weapons plus a mission coordinator, when required. The crew employs the aircraft from inside a GCS via a line-of-sight data link or a satellite data link for beyond line-of-sight operations. The MQ-1B carries the Multi-spectral Targeting System, or MTS-A, which integrates an infrared sensor, a color/monochrome daylight television (TV) camera, an image-intensified TV camera, a laser designator and a laser illuminator into a single package. The full motion video from each of the imaging sensors can be viewed as separate video streams or fused together. The aircraft can
